PHASE I INSPECTION REPORT  
NATIONAL DAM SAFETY PROGRAM

NAME OF DAM: SPRINGHILL LAKE DAM

Name of Dam: Springhill Lake Dam  
State: Virginia  
County: Bedford  
USGS 7.5 Minute Quadrangle: Peaks of Otter, Virginia  
Stream: Unnamed Tributary to the Big Otter River  
Date of Inspection: 5 June 1979

PHASE I INSPECTION REPORT  
NATIONAL DAM SAFETY PROGRAM  
NAME OF DAM: SPRINGHILL LAKE DAM ID# VA 01906

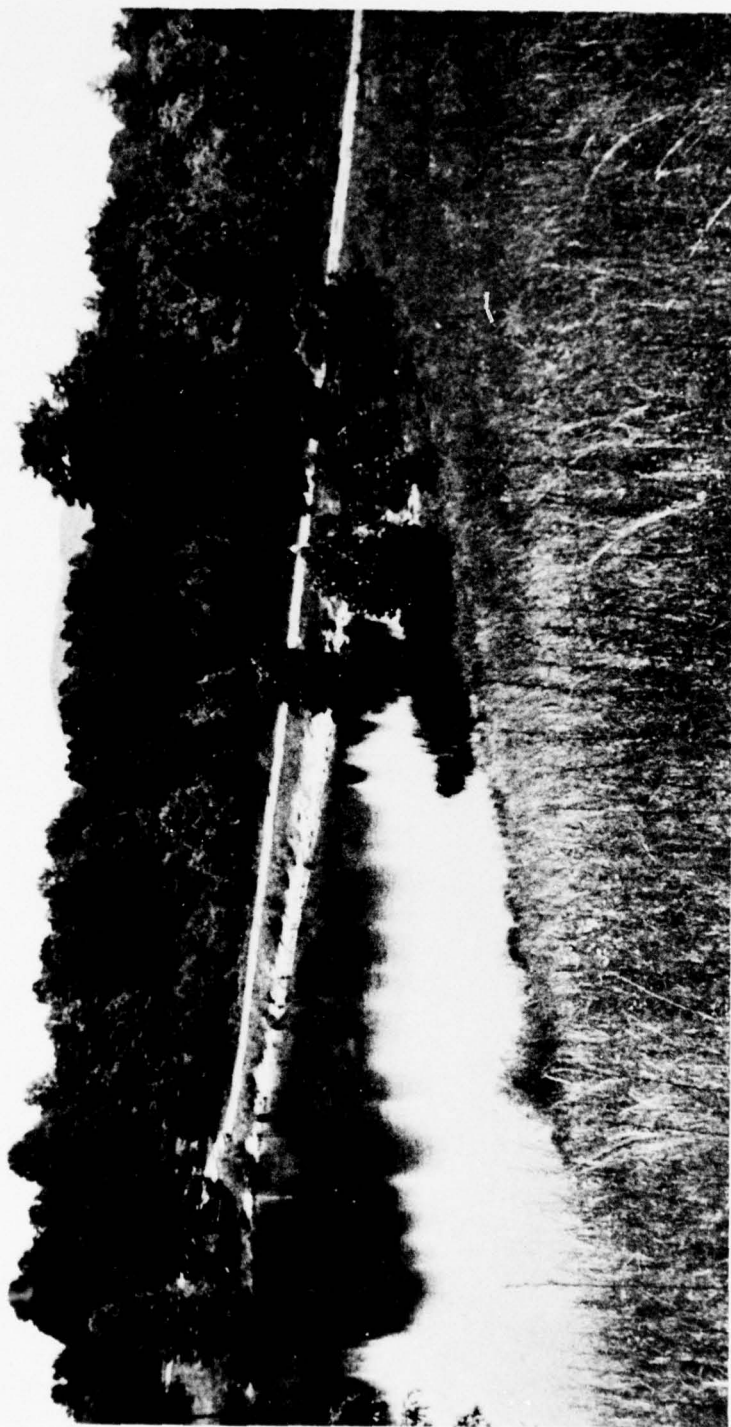
OVERALL VIEW OF DAM

The entire downstream slope is covered with dense brush and large trees (see Photos 2 and 4). A few trees are situated along the waterline near the abutments on the upstream slope (see Overall View of Dam).

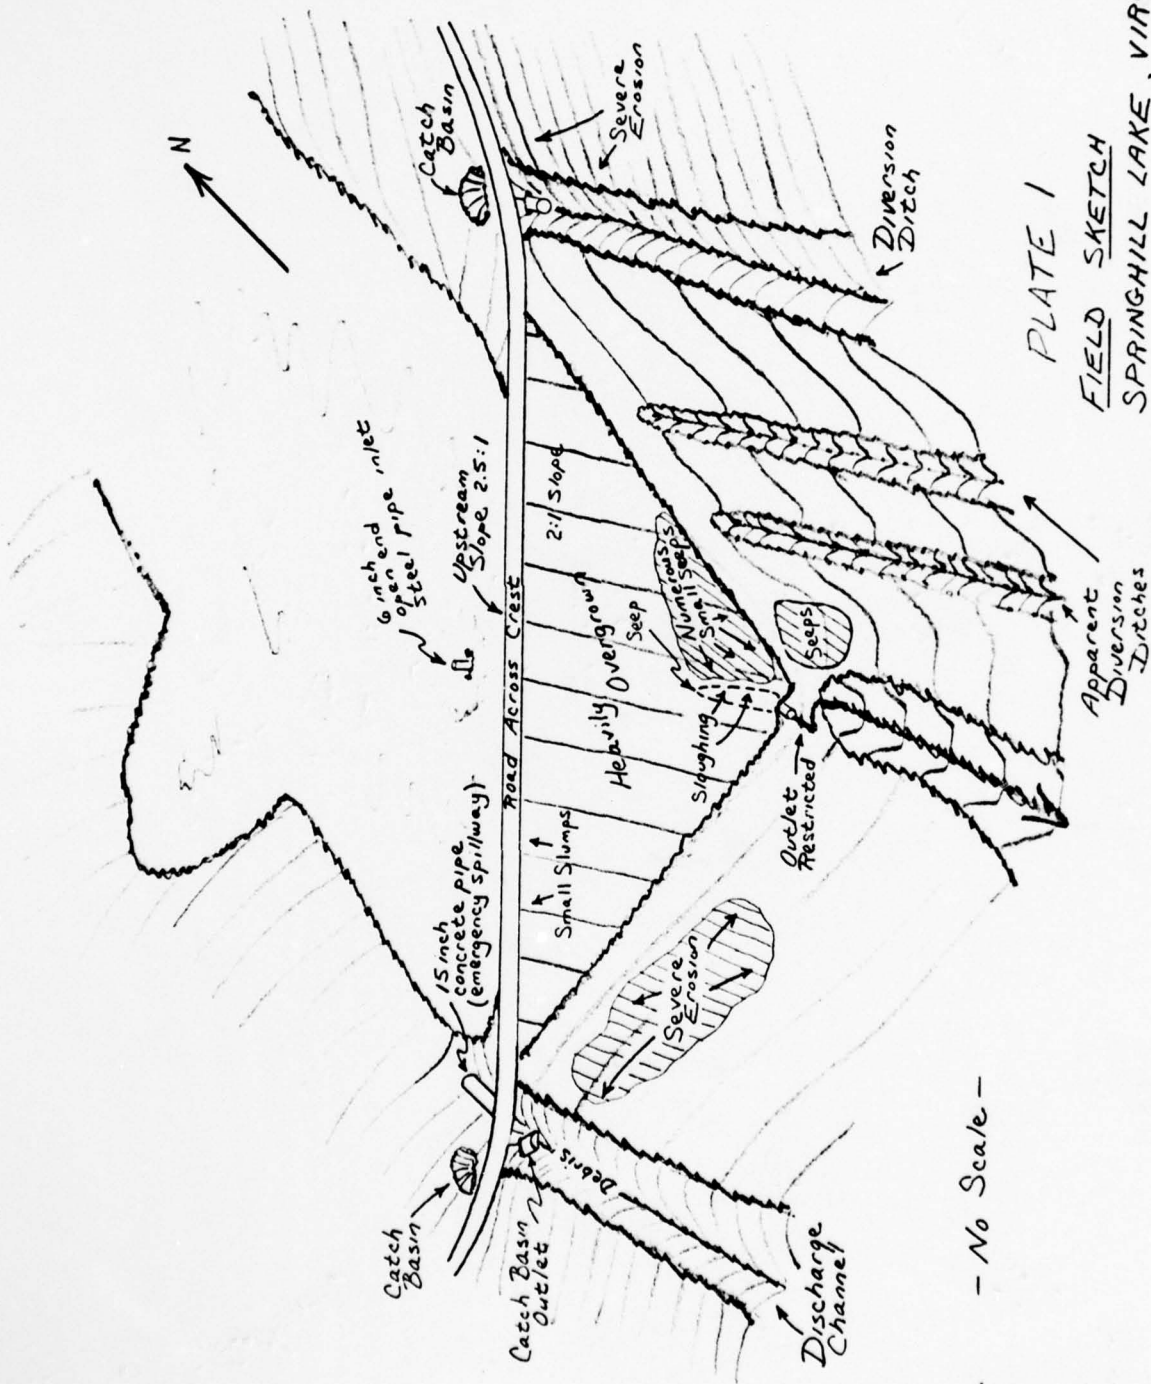
# PLATE 1

Plate 1 is a Field Sketch of the facility which depicts the present conditions. The complete visual inspection check list is included in Appendix III. Following are summaries of the deficiencies noted during the inspection.

FIELD SKETCH  
SPRINGHILL LAKE, VIRGINIA

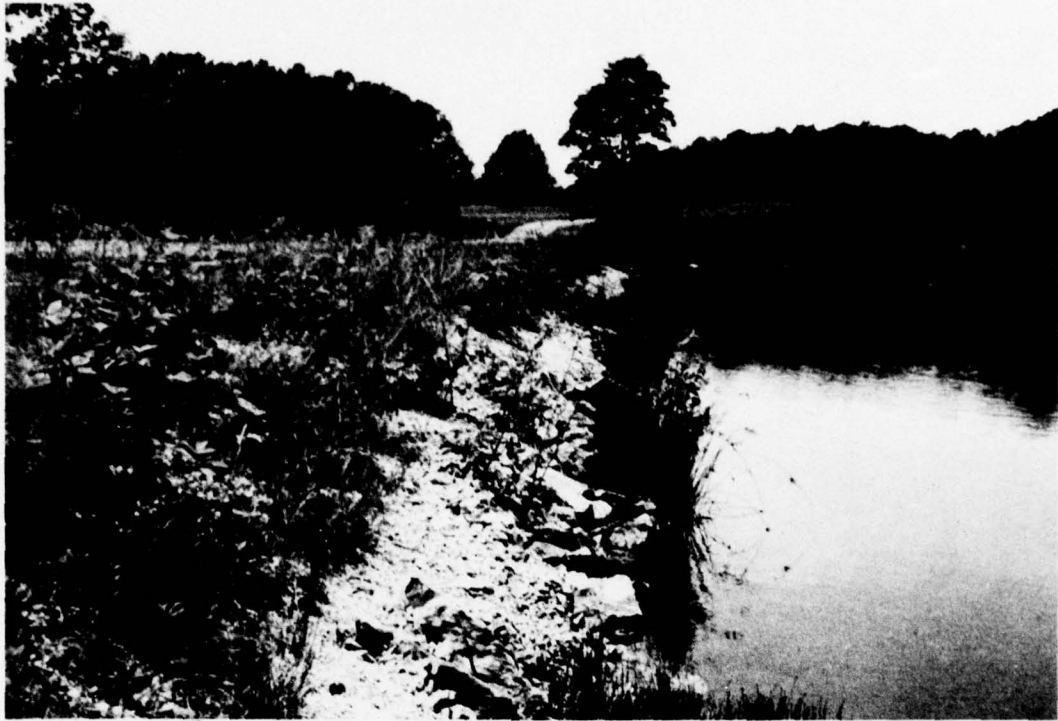
(see Photo 1). Much of the riprap is small and washes away easily.

The upstream embankment appears to be generally in good condition except for the observation that the riprap does not uniformly cover the embankment. Because much of the riprap is undersized, it readily erodes and washes downstream.

**PHOTO 1. Upstream Embankment with Riprap**

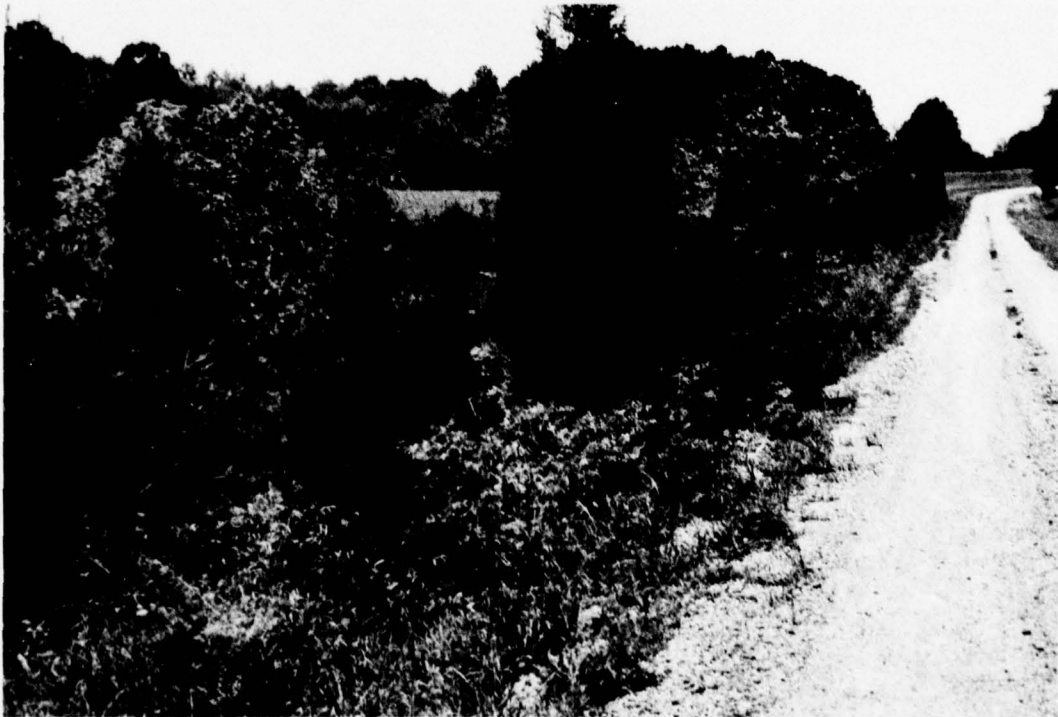
**PHOTO 2. Gravel Road Across Crest and Downstream Embankment**

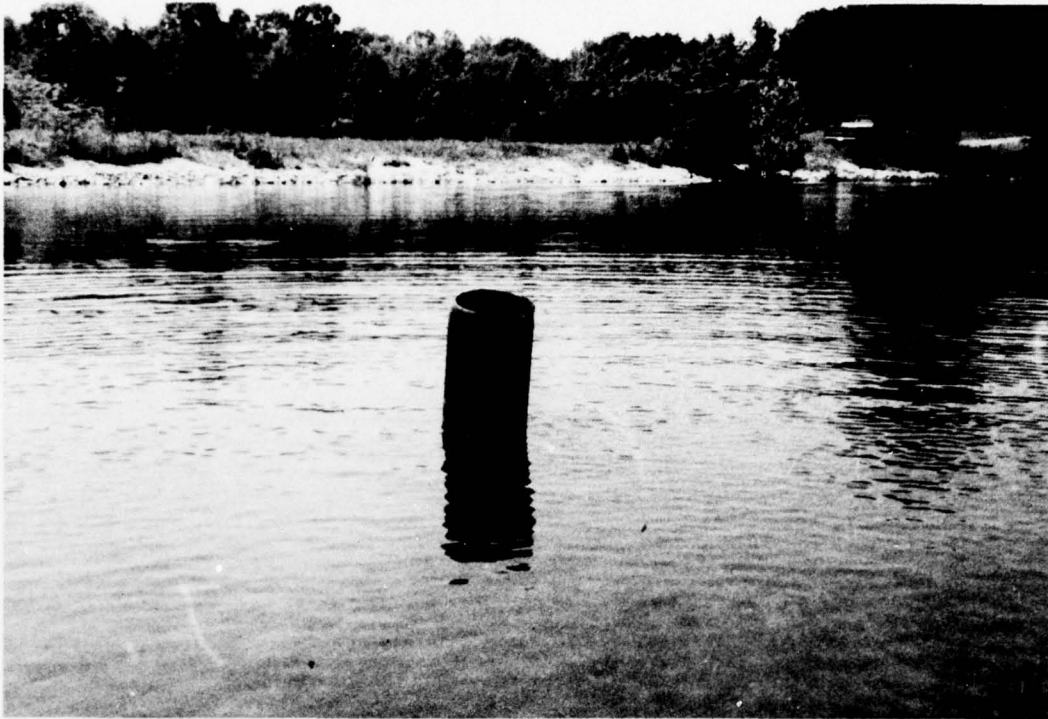
The principal spillway consists of a vertically standing 6 inch cast-iron pipe located approximately 125 feet from the upstream crest of the dam (see Photo 3). Normal discharges

The principal spillway inlet (see Photo 3) is not screened and is unprotected from clogging by floating debris. In addition, the cast-iron pipe which comprises the spillway appears to be unsupported and is leaning noticeably upstream. The discharge area for the principal spillway (see Photo 4) is clogged by vegetation. A stilling basin and riprap have not been provided to protect against erosion at the toe of the dam.

**PHOTO 3. Principal Spillway Inlet (six inch steel pipe)**

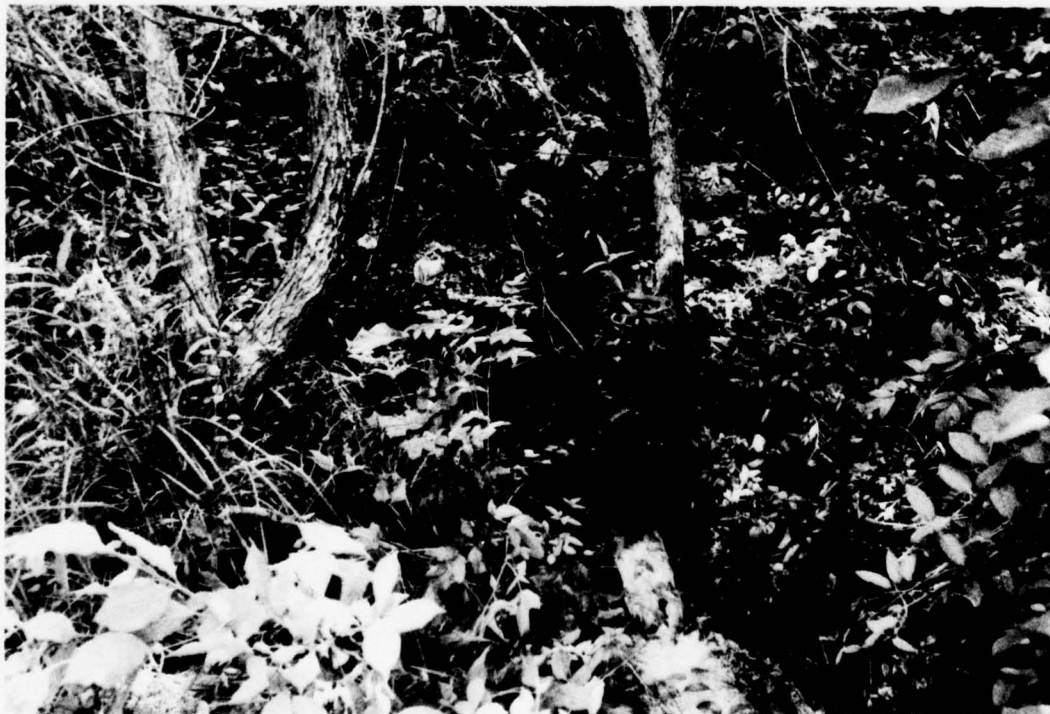
from the reservoir enter the outlet pipe through three 3 inch diameter holes cut in the side of the pipe. When the reservoir level rises approximately 1.4 feet above the normal pool elevation of 825.0 feet M.S.L., water enters the open end of the pipe. The pipe outlets at the downstream toe of the dam (see Photo 4) near the midpoint of the embankment.

**PHOTO 4. Principal Spillway Outlet**

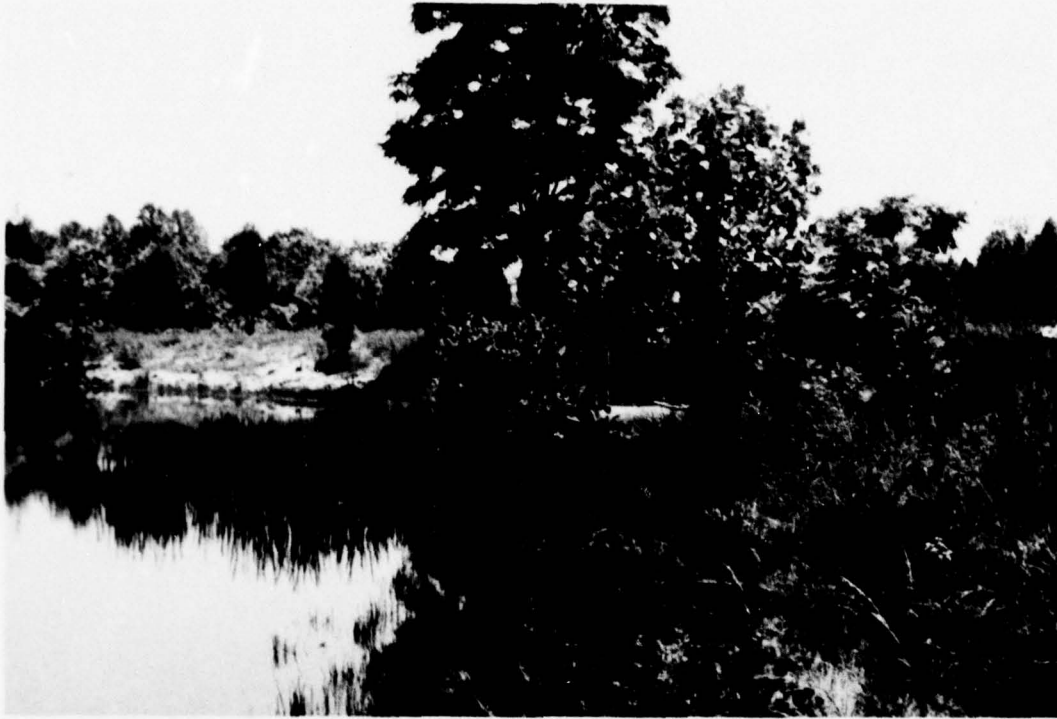
The emergency spillway, the entrance of which is located near the right<sup>3</sup> abutment, is a 15 inch diameter reinforced concrete pipe (see Photo 5). The outlet of this spillway could not be located during the inspection and is believed to be buried (see Photos 6 and 7 and Plate 1). The spillway is therefore considered non-functional at the present time.

**PHOTO 5. Emergency Spillway Inlet**

The 15 inch reinforce concrete pipe acting as an emergency spillway should be immediately returned to operating condition.

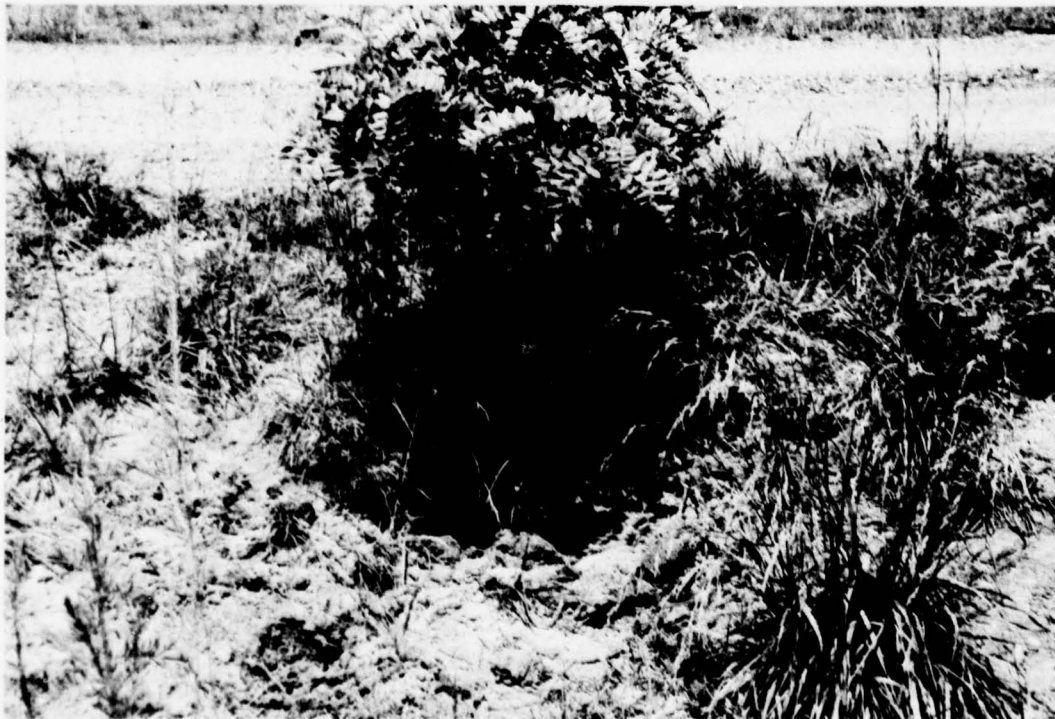
- 3.1.3 Appurtenant Structures: The discharge end of a 15 inch reinforced concrete pipe which serves as the emergency spillway could not be located and is believed to be buried in sediment (see Photo 1). Near the anticipated outlet end an identical pipe was observed, but because of its orientation and elevation it is believed to be the outlet for water collected by a catch basin on the right end of the dam (see Photo 6 and Plate 1).

**PHOTO 6. Catch Basin Outlet at Right Downstream End of Dam**

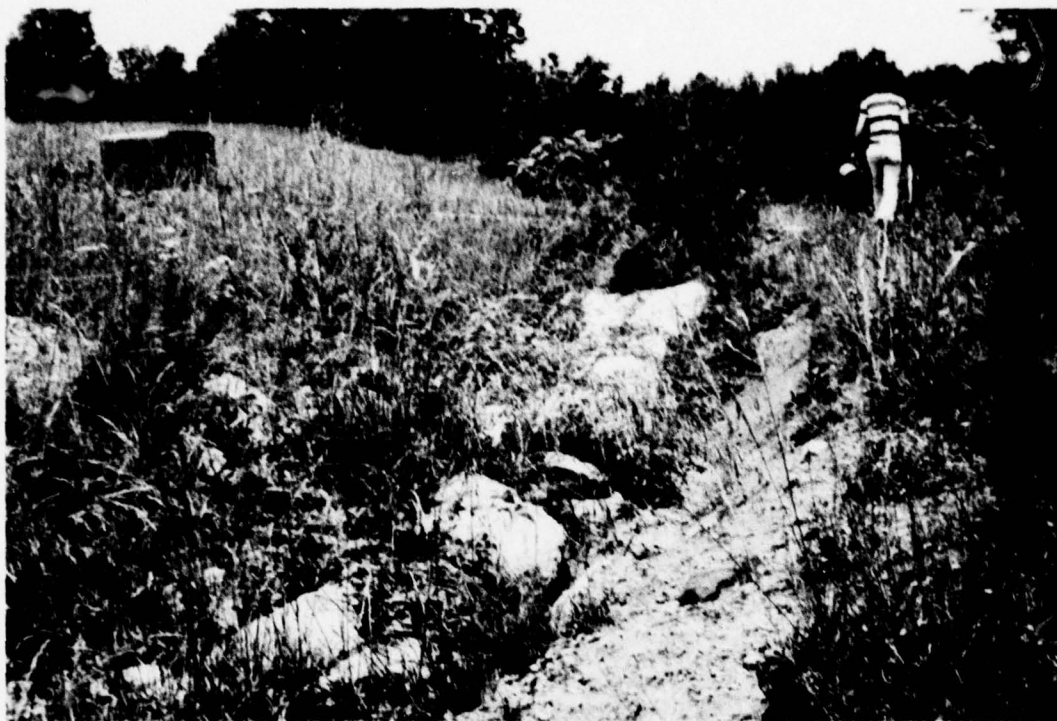
The discharge channel for the emergency spillway pipe outlet and the catch basin outlet is clogged with debris (see Photo 7). As a result, water has washed out of this discharge channel onto the right downstream abutment of the dam and caused severe erosion (see Photo 8). This erosion has approached the junction of the abutment with the downstream embankment.

The discharge channel from a pipe draining a catch basin on the right side of the dam was severely blocked with debris. This debris causes water to leave the channel and flow over the right abutment of the dam. The abutment is highly eroded. The erosion is proceeding toward the junction with the embankment. This condition,

**PHOTO 7. Discharge Channel of Emergency Spillway**

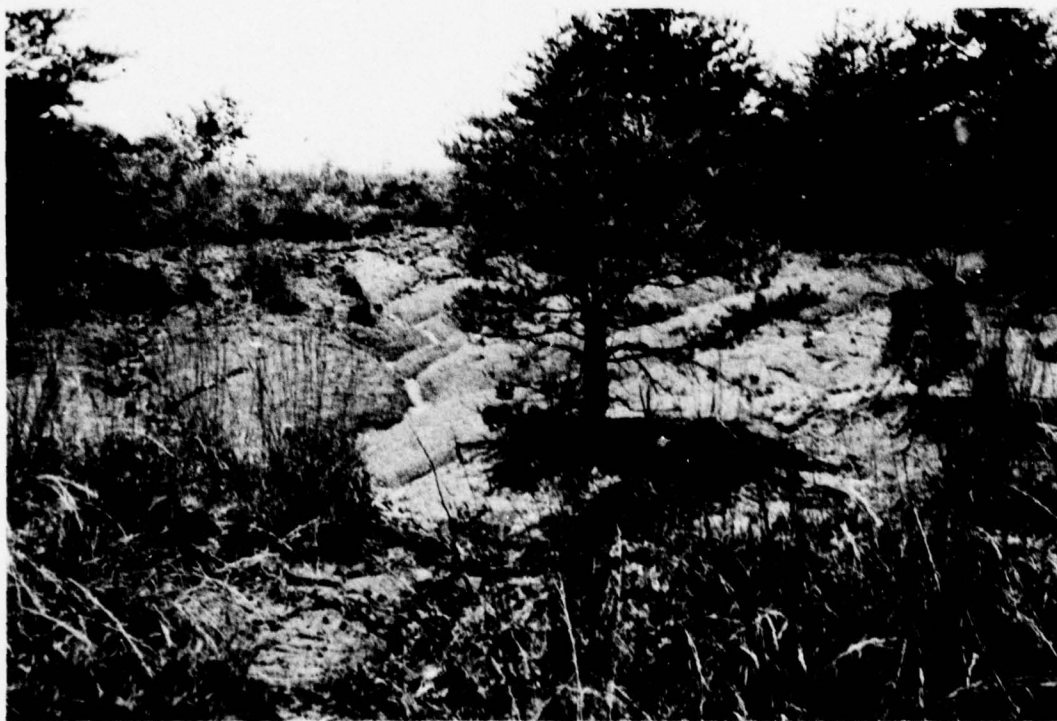
Under operable conditions, water running through the emergency spillway discharge channel encounters debris and washes over the right downstream abutment causing erosion. With time this erosion could affect the junction of the downstream embankment with the right abutment. The integrity of the principal spillway inlet is questionable because it is leaning noticeably. It is not known whether the spillway was originally installed at this angle or the leaning is an indication of a possible failure. A support structure was not observed for the riser (cast-iron pipe) during the visual inspection.

**PHOTO 8. Erosion on Right Downstream Abutment**
